=====
Survey Report No. : I-XXI-01001
Date : 01st of March 2021
=====

"ARVIN"
(IMO No.: 8874316)

Marine Casualty Investigation

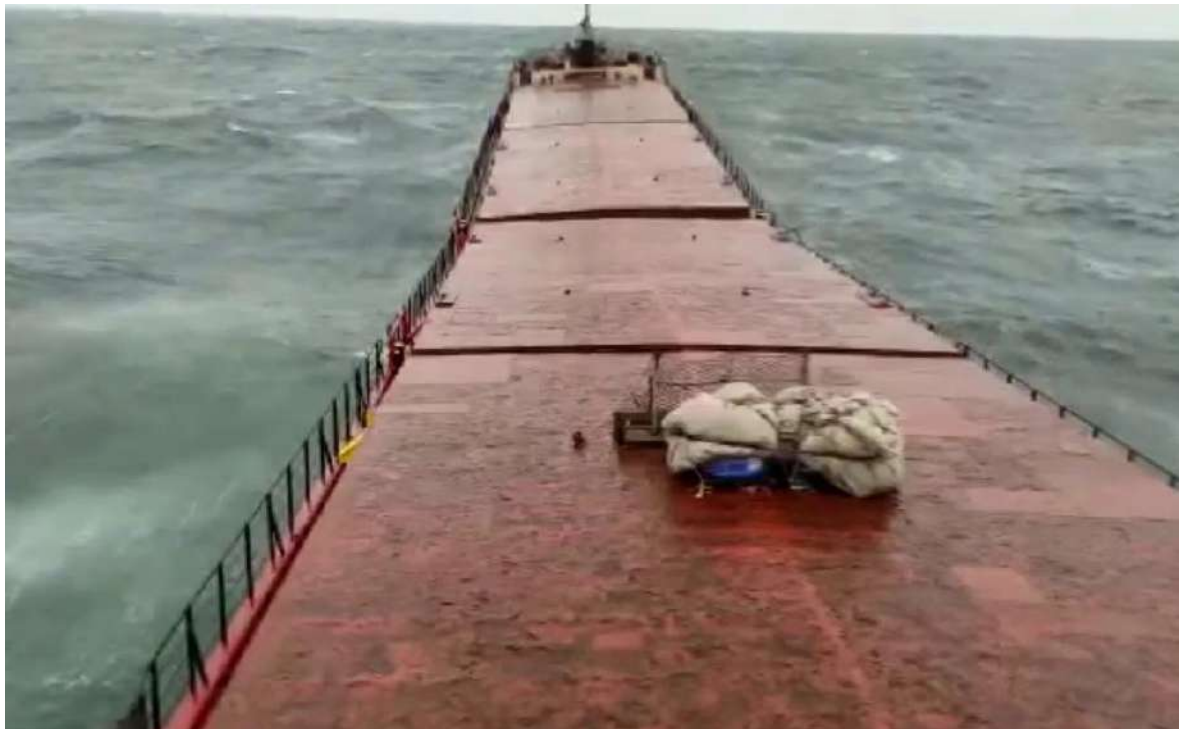
Photo 1: *The "ARVIN" at the moment of incident (extract from video recording from the Bridge)*

Based on the forgoing, the catastrophic structural failure causing the breaking and splitting in two of the ship's hull at around midships and the resultant sinking of the vessel, may be reasonably attributed the hull structure having weakened to a degree which could not sustain the bending stresses imposed by the weather conditions (swell/waves) in conjunction with the loaded condition of the vessel.
